Project Number: 19-009

Subject: 301 Mission Retrofit Monitoring Report 016: Results as of August 18, 2021

Millennium Tower Perimeter Pile Upgrade: Instrumentation Monitoring Data City and County of San Francisco, California

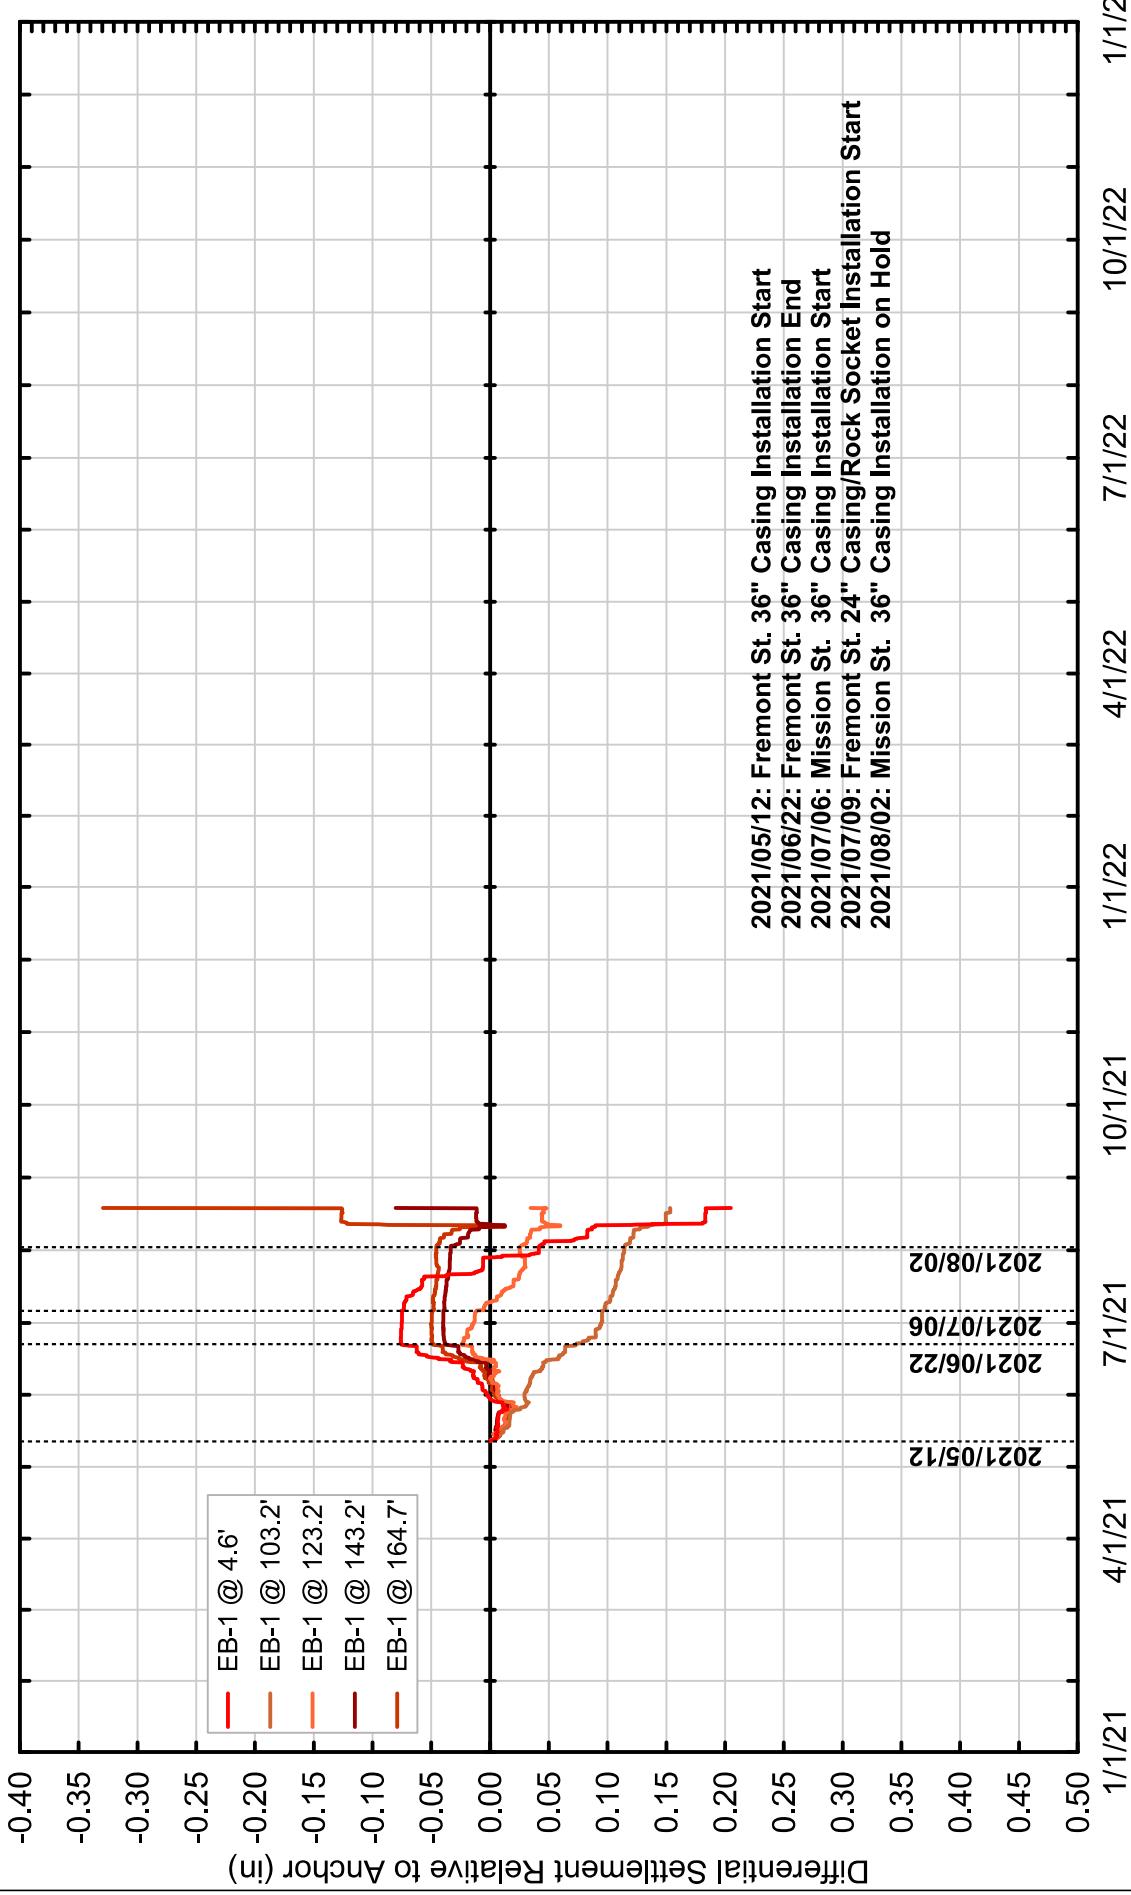
Project No: 19-009.00	Date: 8/18/2021	Created By: NBW	Checked By: DGM	Figure No: 016-11
SLATE GEOTECHNICAL CONSULTANTS

Street since the start of production pile installation (May 12, 2021) through August 18, 2021. Figure 12 presents extensometer data from Mission Street since the start of production pile installation (May 12, 2021) through August 18, 2021.

DIFFERENTIAL EXTENSOMETER DATA FROM FREMONT STREET
SINCE 01/01/2021 THROUGH 08/18/2021

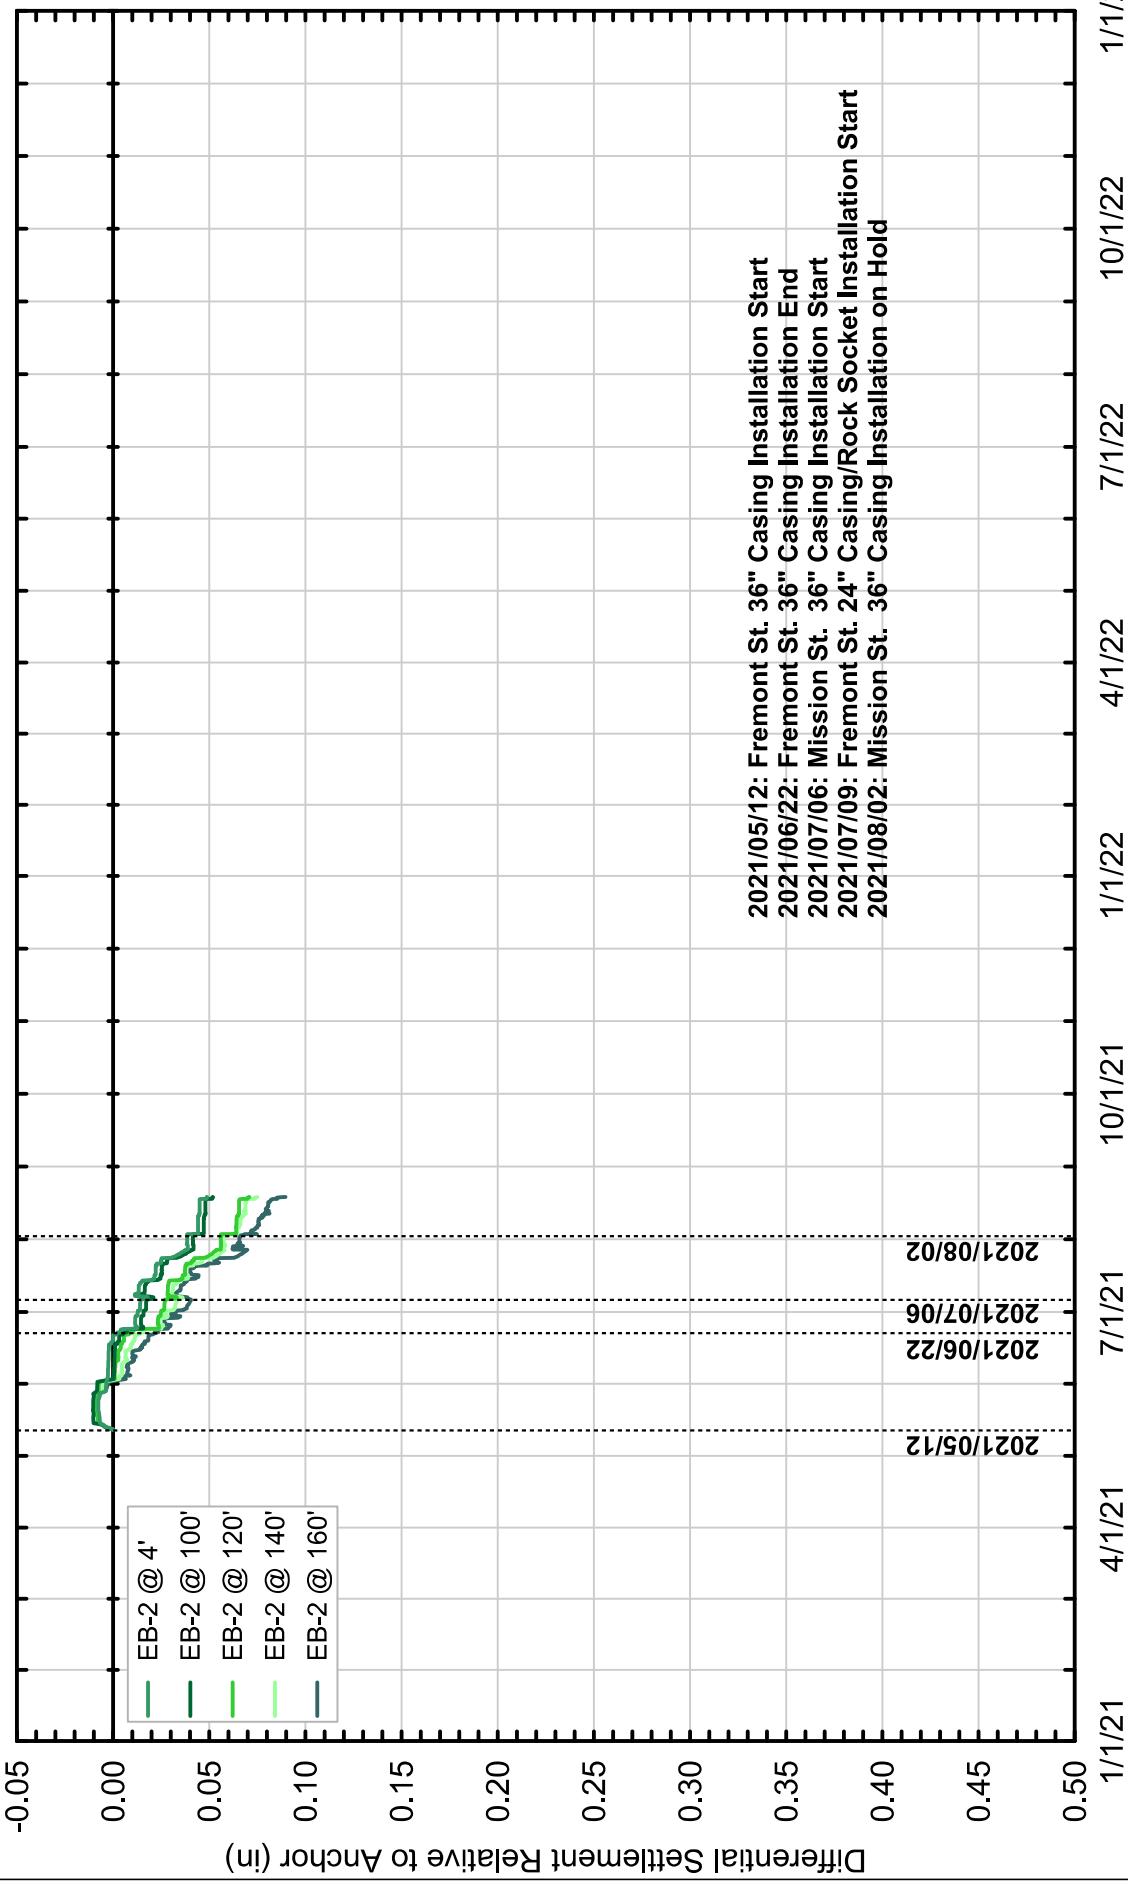
Project No: 19-009.00	Date: 8/18/2021	Created By: NBW	Checked By: DGM	Figure No: 016-12
DIFFERENTIAL EXTENSOMETER DATA FROM MISSION STREET SINCE 01/01/2021 THROUGH 08/18/2021

2021/05/12: Fremont St. 36" Casing Installation Start
2021/06/22: Fremont St. 36" Casing Installation End
2021/07/06: Mission St. 36" Casing Installation Start
2021/07/09: Fremont St. 24" Casing/Rock Socket Installation Start
2021/08/02: Mission St. 36" Casing Installation on Hold
